# Roof condition report

# 123 Main Street

SIX ILLUSTRATED FINDINGS · REPAIR PRIORITIES · NEXT STEPS

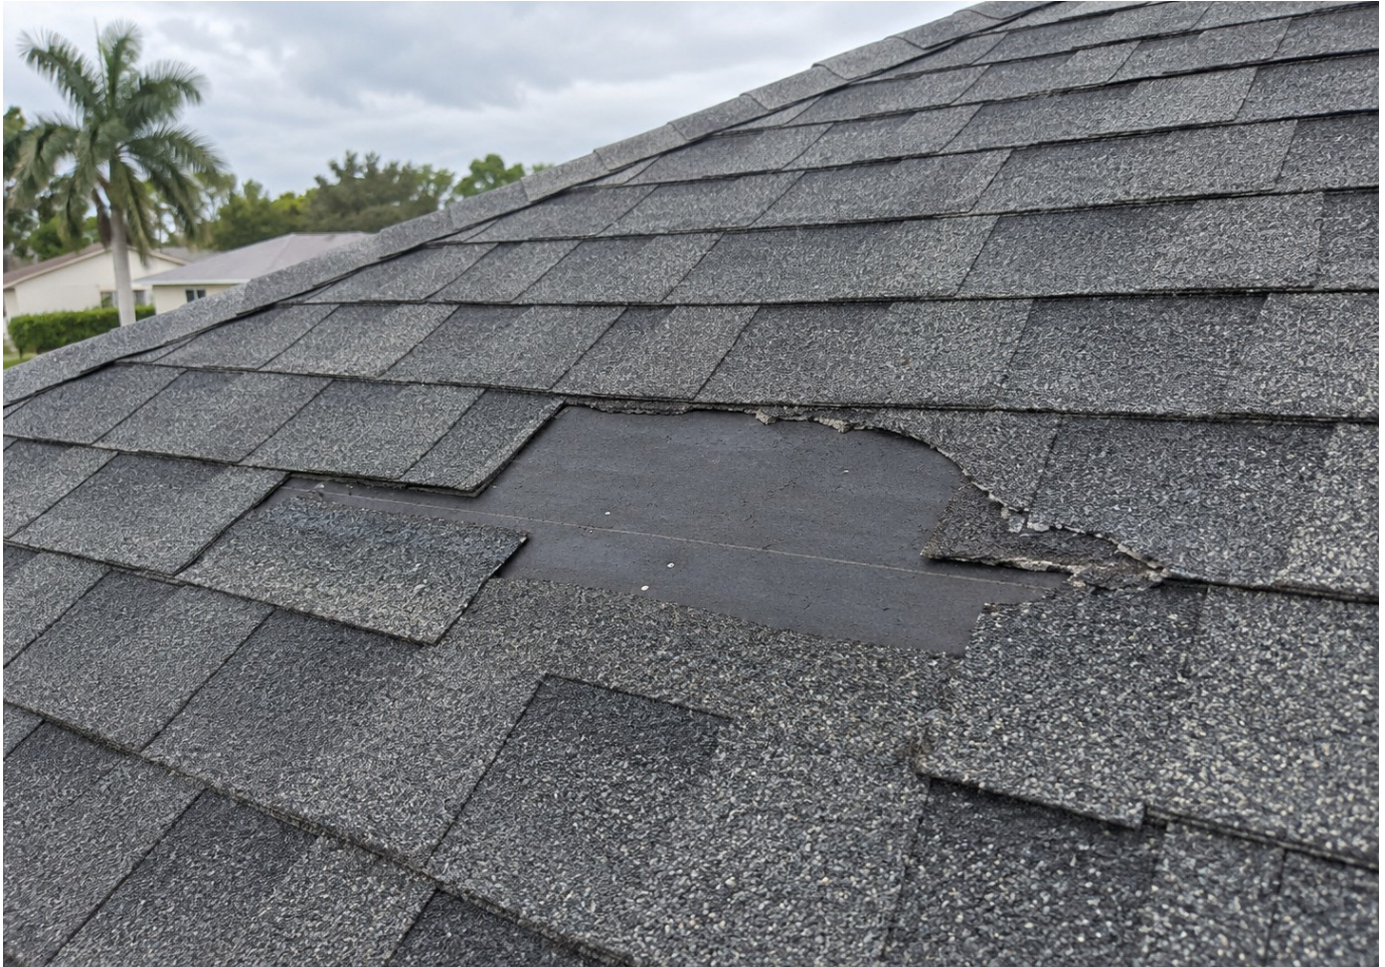
**IMAGE 01 / AI-GENERATED EXAMPLE — NOT AN INSPECTION PHOTO**

# Missing shingles

Front slope · lower field · Example location

An exposed patch interrupts the granulated shingle surface.

Shingle material is missing from a localized section of the slope. A smooth, dark layer beneath is exposed, with torn edges around the opening.

The primary roof covering is interrupted. Water can reach underlying layers that are normally protected by the shingles.

Have a roofer assess the exposed area and surrounding shingles, then replace damaged materials with compatible products. Confirm the underlayment and decking condition when the area is opened.

Confirm the affected area, material compatibility, fastening and sealed overlaps. Record completion photos before and after the covering is restored.

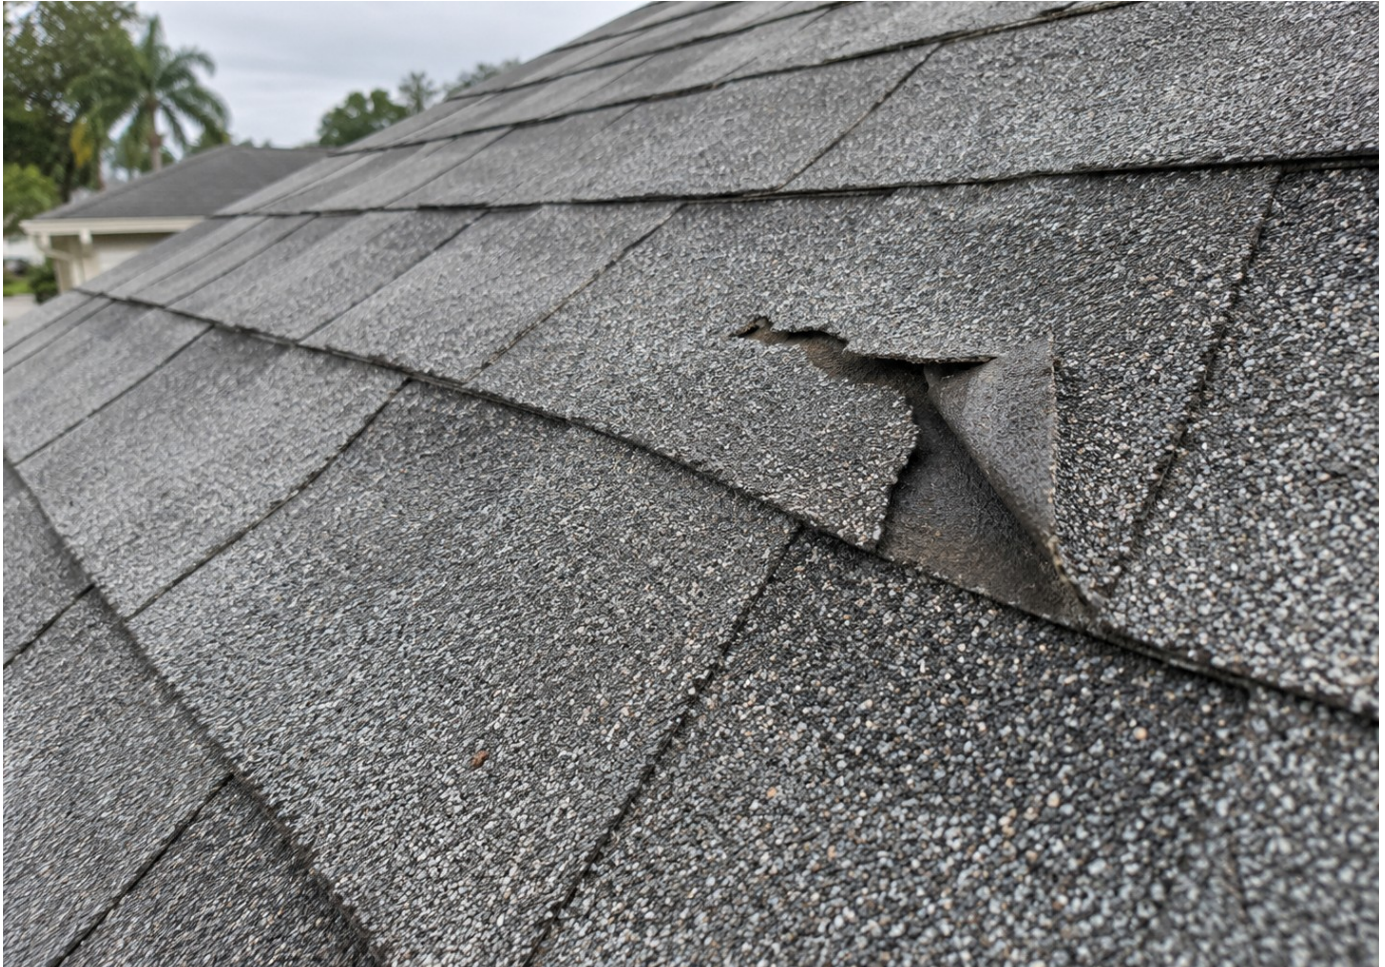
**IMAGE 02 / AI-GENERATED EXAMPLE — NOT AN INSPECTION PHOTO**

# Torn and lifted shingle

Front slope · mid-field · Example location

The break crosses the shingle body; it is not a normal overlap.

A shingle has a jagged tear through its body. The broken flap is lifted and curled back, exposing its underside.

The torn tab no longer sheds water as intended. Movement of the loose flap can enlarge the damaged area.

Evaluate the damaged shingle and the adjoining courses for repairability. Replace the torn material and restore proper fastening and sealing following the product requirements.

Check adjacent shingles for additional tears and disturbance during repair. A cause or date of damage cannot be established from this image.

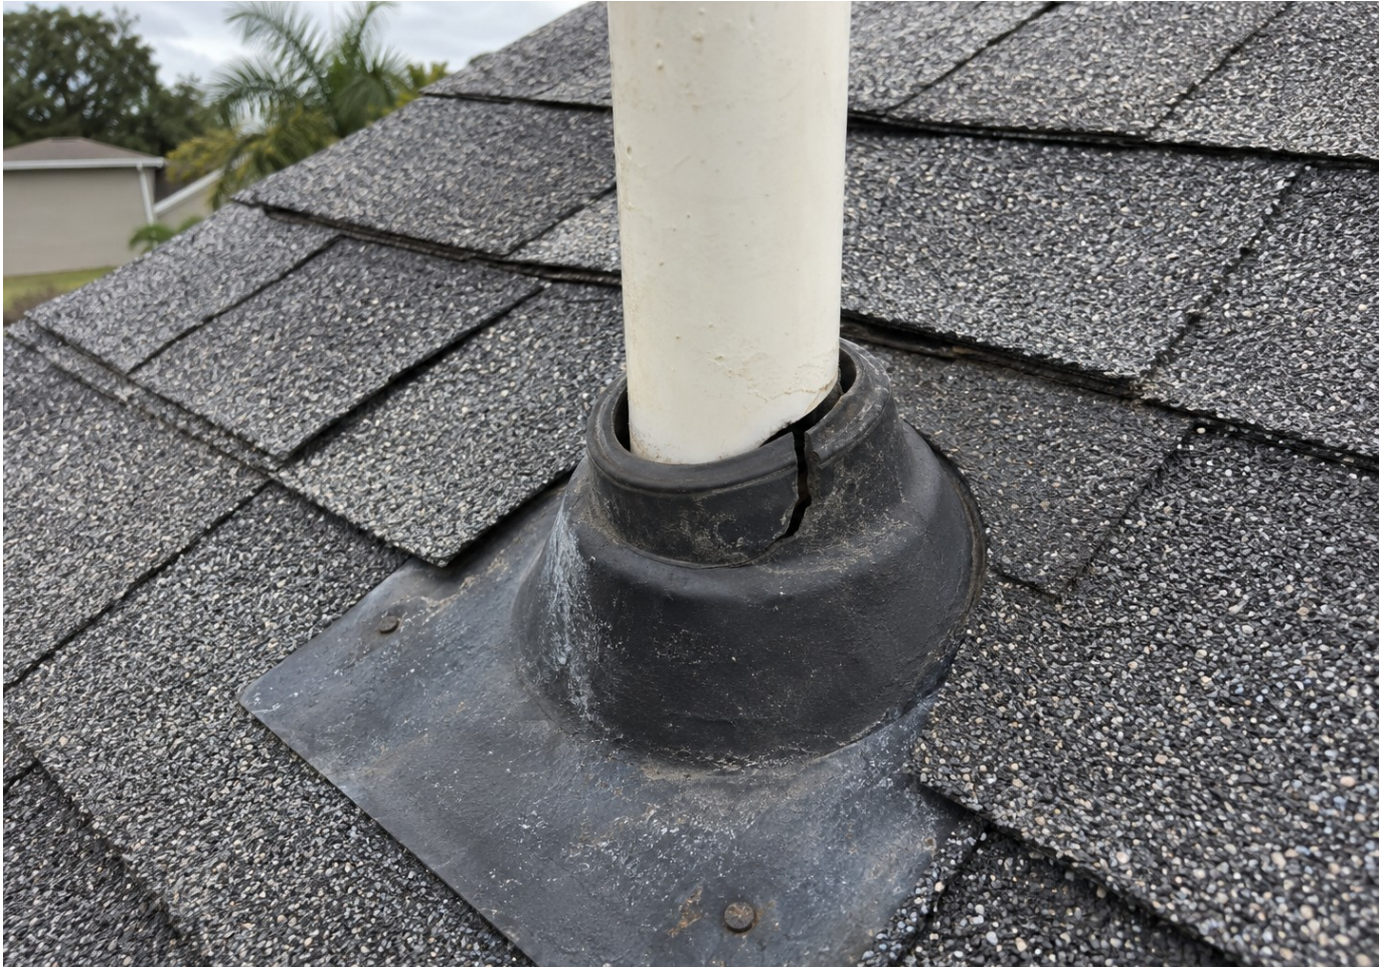
**IMAGE 03 / AI-GENERATED EXAMPLE — NOT AN INSPECTION PHOTO**

# Split plumbing-vent boot

Rear slope · plumbing vent · Example location

The split and open collar interrupt the seal around the pipe.

The rubber collar has a visible split beside the vent pipe, and a gap is present where the collar should fit around the pipe.

The opening can admit water at a roof penetration. Any moisture beneath the boot remains unverified.

Have a roofer evaluate the boot, flashing base and surrounding roofing. Use a compatible manufacturer-approved repair or replacement assembly to restore the seal and drainage detail.

Confirm pipe size, boot fit and flashing overlaps. Inspect nearby decking when accessible; do not assume a surface bead of sealant resolves the defect.

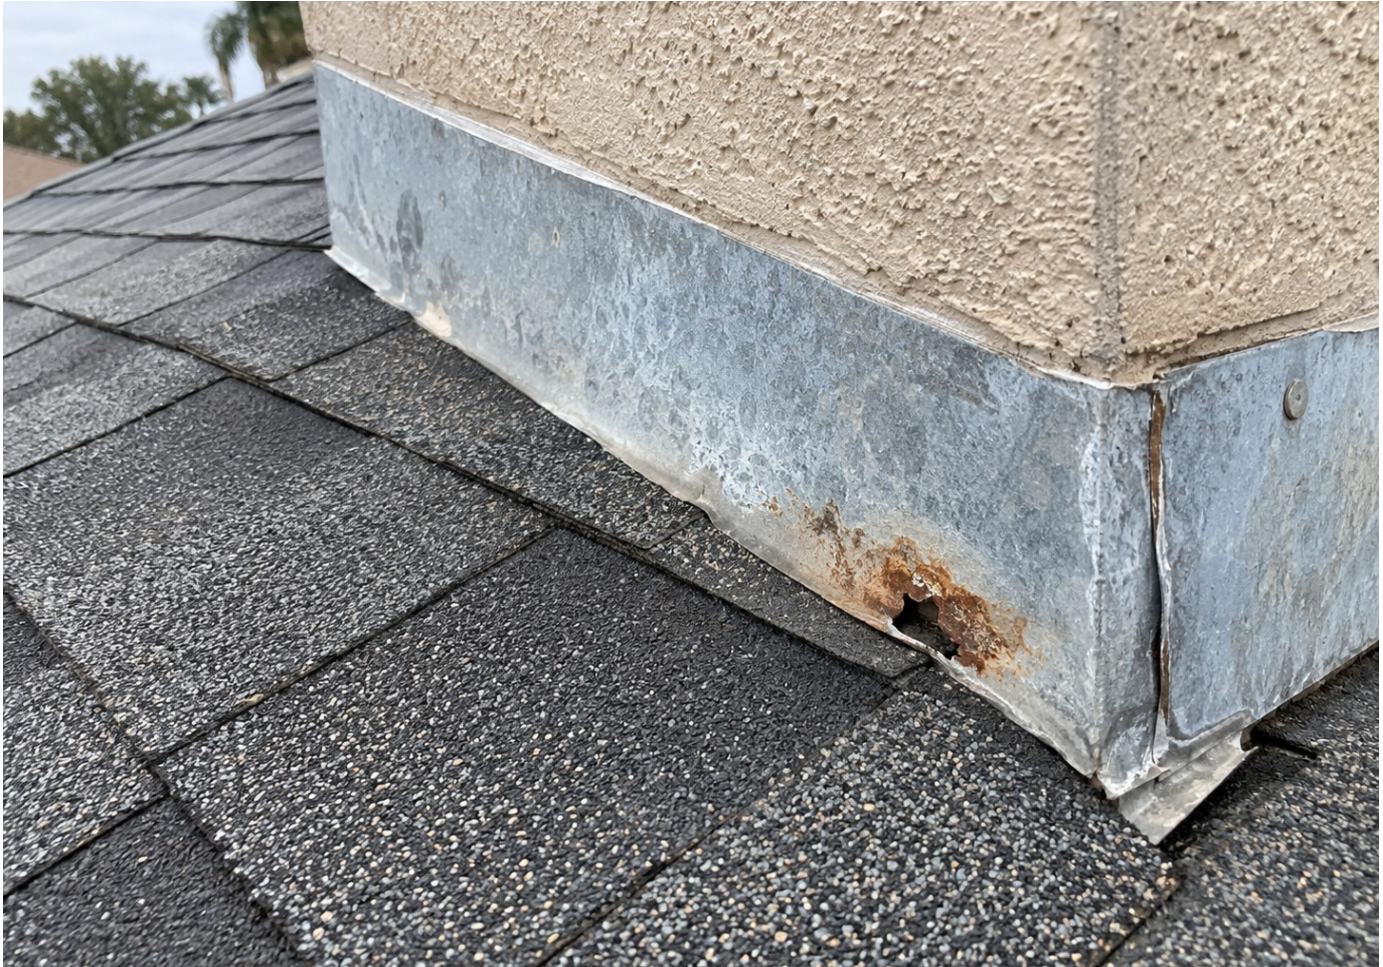
**IMAGE 04 / AI-GENERATED EXAMPLE — NOT AN INSPECTION PHOTO**

# Corroded chimney flashing

Rear slope · chimney base · Example location

A hole is visible in the corroded metal near the lower edge.

The exposed chimney-base metal has localized corrosion with a visible rust-through opening near its lower edge.

The perforated flashing is no longer a continuous water-shedding barrier at the roof-to-chimney junction.

Evaluate the full chimney flashing detail and replace deteriorated sections with compatible materials. Review adjoining overlaps and terminations, rather than treating only the visible rusty spot.

Confirm the extent of corrosion and the condition behind the flashing during repair. Concealed water damage is not established by this image.

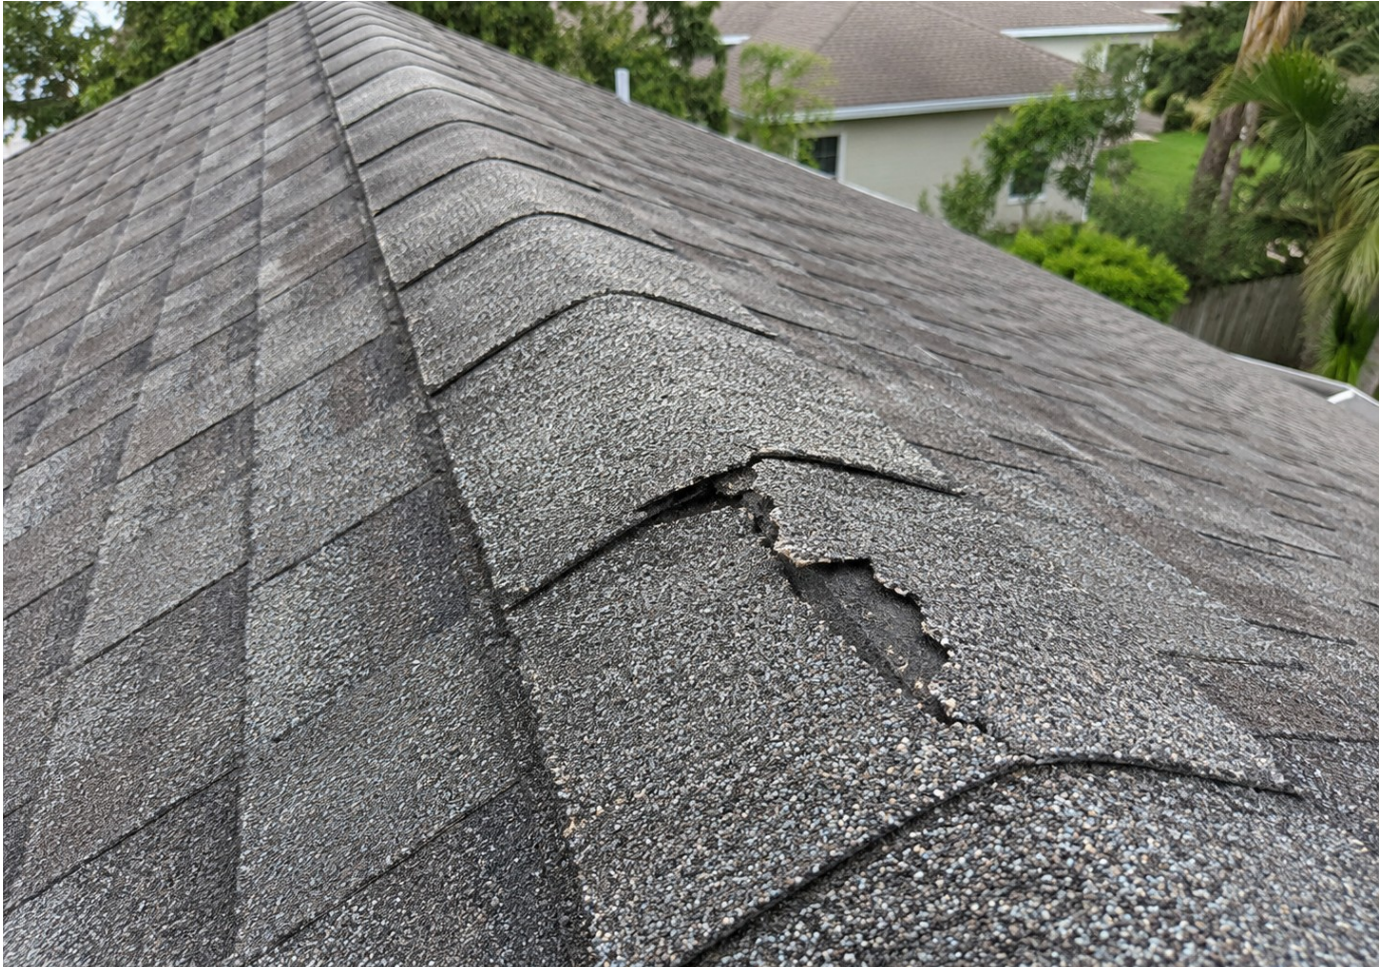
**IMAGE 05 / AI-GENERATED EXAMPLE — NOT AN INSPECTION PHOTO**

# Broken ridge-cap shingle

Main ridge · front end · Example location

The jagged break crosses the cap and exposes a darker layer.

A ridge-cap shingle is split across the crest and has missing material. A darker underlying layer is visible through the damaged area.

The ridge covering is interrupted at a high, exposed part of the roof. The opening warrants review of the ridge assembly beneath.

Evaluate nearby cap shingles and any ridge-vent components. Replace damaged cap material with a compatible system and restore fastening and overlaps to the product requirements.

Check whether damage is isolated or repeated along the ridge. Document the repaired cap and any additional findings before closing the work.

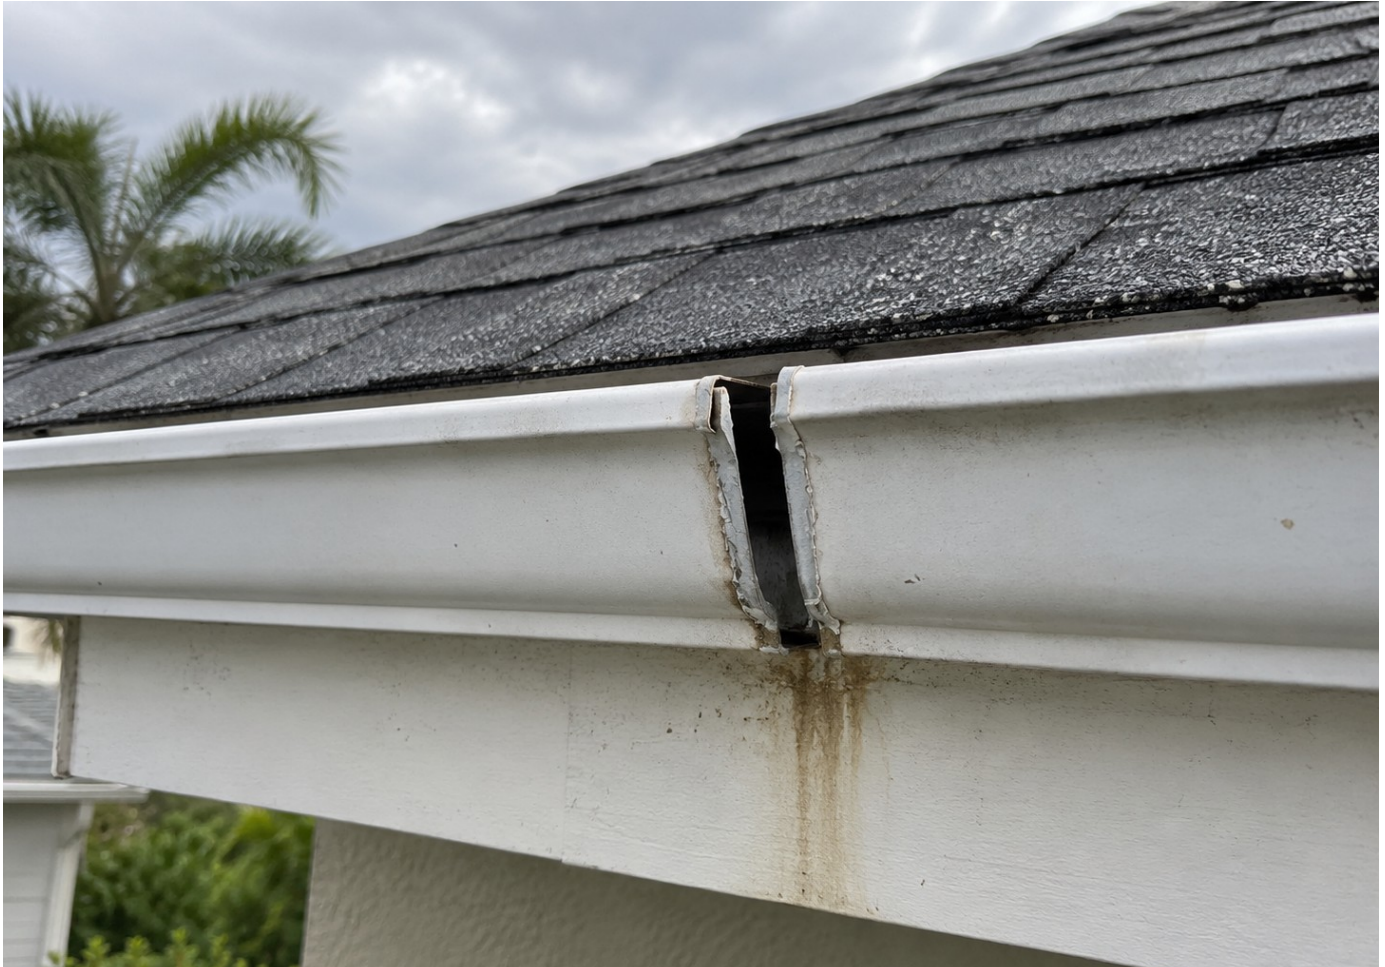
**IMAGE 06 / AI-GENERATED EXAMPLE — NOT AN INSPECTION PHOTO**

# Separated gutter joint

Front eave · gutter splice · Example location

The open splice and staining below it identify the area to investigate.

Two gutter sections have separated at a splice. The seam is visibly open, and staining appears on the fascia below it.

Runoff can escape at the joint instead of reaching the downspout. The stain alone does not prove that the fascia is decayed.

Repair or replace the failed joint, check nearby supports and gutter alignment, and inspect the stained fascia. Confirm drainage after the repair with a controlled check.

Record whether the joint holds water and whether the fascia is sound when inspected. Revise the scope if concealed damage is found.
